Moisture and Your Floor by Chris O'Brien

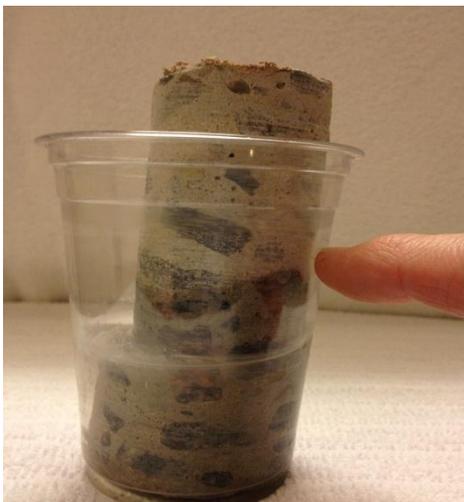
Water wicks up concrete just like a sponge. If this Moisture is trapped above an effective vapor barrier it can cause moisture related failures once locked in.
